## 45149 Headcode Mystery Solved

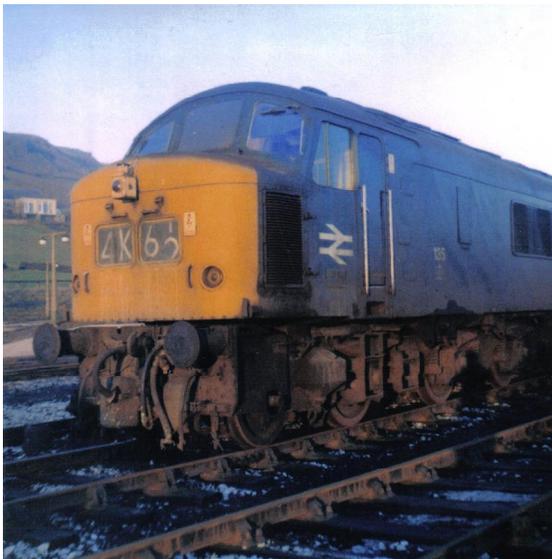
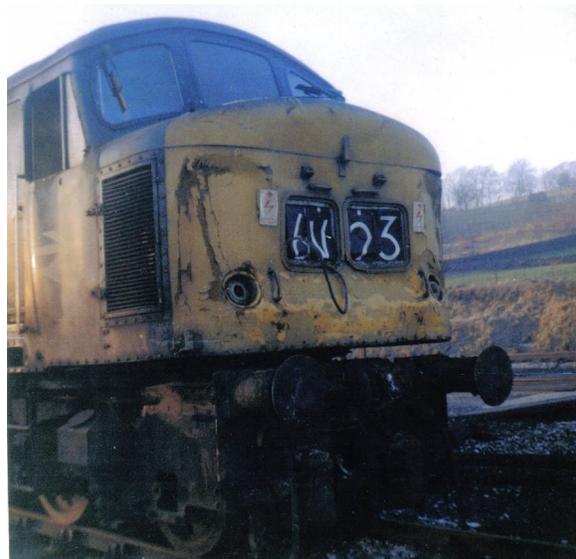
135 displaying the damage to No.1 end – Chinley, January 1971 (Photos: Steve Gross)

Finally we knew what damage had been sustained, along with the month and year. However it would still be interesting to know exactly what happened to cause the damage. The headcode displayed on the damaged No.1 end may give a clue. 6V23 is the code for a Tunstead – Margam stone train, which at the time used to have to run round at Chinley to head towards Sheffield. The BR Safety Report of 1971 mentions an incident at Chinley where a loco was uncoupled from its train at Chinley North Jn to run round via Chinley station and the wagons ran away down the gradient, following the loco and then colliding with it. Could this be the explanation? If anybody has any further information on this please let me know by emailing [dexter-skiddaw@sky.com](mailto:dexter-skiddaw@sky.com).

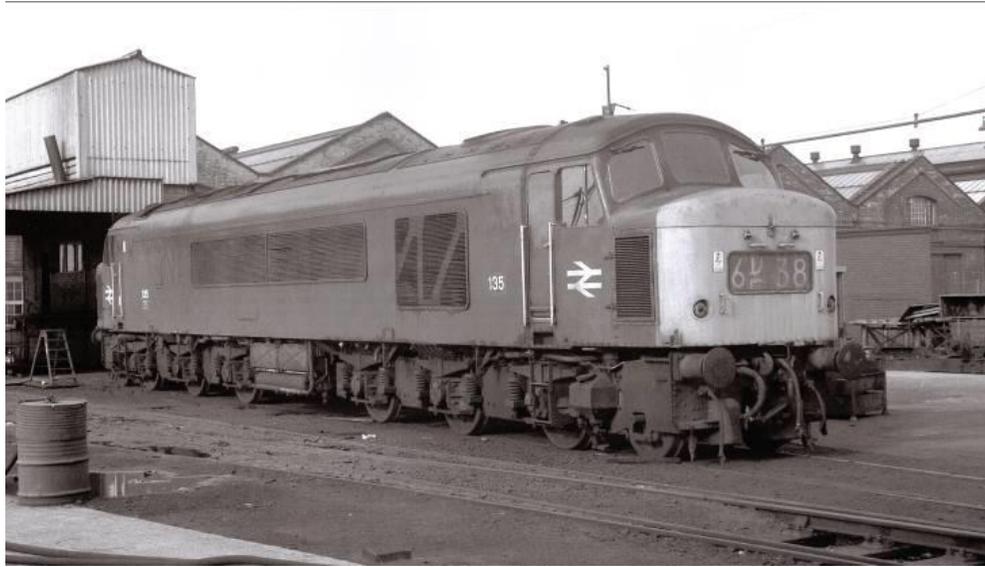
135 showing the modified headcode arrangement following repairs at Derby Works  
(Photo: Kevin Connolly)

When 45149 was built as D135 in 1961, it was fitted with split headcode boxes mounted in the centre of each nose end. However by 1973, No.1 end cab had been modified with a one piece headcode panel, whilst No.2 end still had split boxes (this arrangement has been restored on the loco in preservation) On researching the history of the loco I was unable to find out why it had been modified in this way except that it had occurred between 1967 and 1973 and presumably as a result of accident damage. Trawling through websites, old magazines and accident reports failed to unearth any information. Then, whilst visiting the Mid Norfolk Railway in March 2010 to enjoy 45133 in action, I had a conversation with Class 45/1 Preservation Society Membership Secretary, Steve Gross. Steve happened to mention that he had a photo of an accident damaged peak at Chinley. Initially I thought this must be 45014, involved in the collision with 31436 in 1986, but then Steve said it was taken when he lived in Chinley in the late '60s early '70s! I asked Steve if I could have copies of the photos and they duly arrived in the post the following week. As soon as I took them out of the envelope the loco number stood out – 135. Mystery solved (well partly). Steve's notes state that the pictures were taken in January 1971 and that the loco stood in the yard at Chinley station for a few days before being towed away. Magazine notes of the time report that 135 was in the yard at Derby Works on 8<sup>th</sup> February 1971, so this coincides. Also, one of the restoration team working on No.1 cab had found '1971' written in marker pen under the lining.
